**Manzana Creek Watershed Anthropogenic Sediment
Reduction Assessment, Aquatic Protection and Road
Restoration Planning Project, Los Padres National Forest**

PWA Report No. 191029001
June 2019

National Fish and Wildlife Foundation (NFWF)
NFWF Grant ID: 0806.17.055580

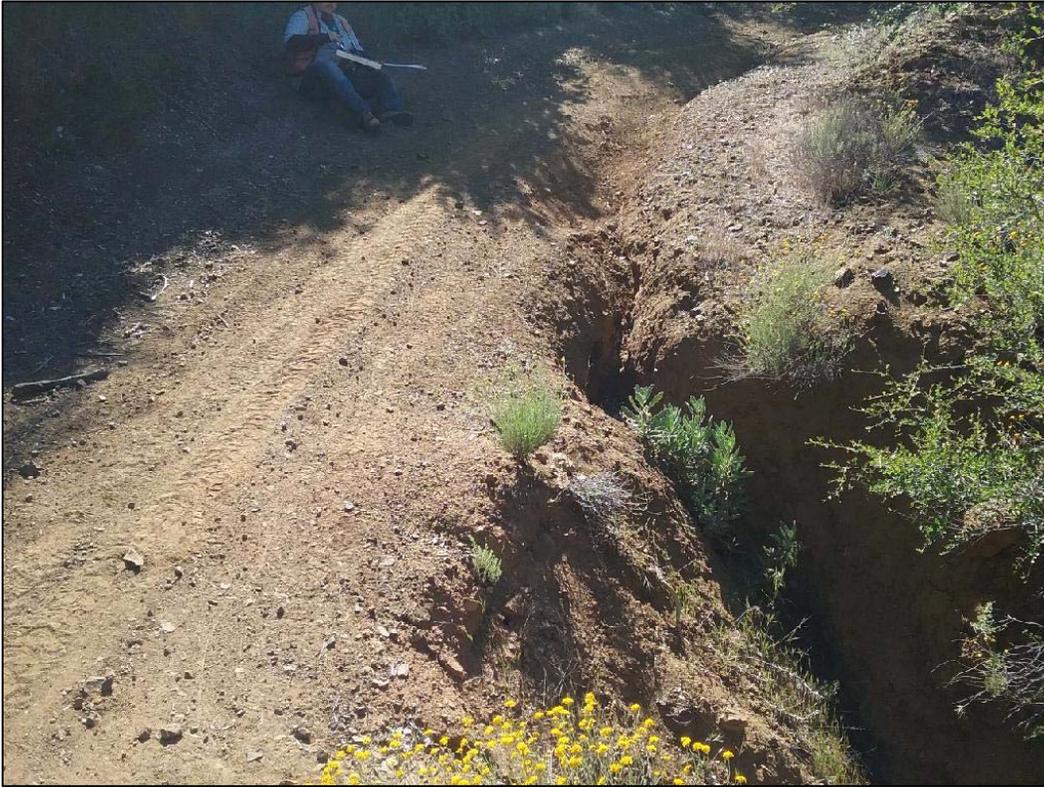
Photo 1

Photo #	Site #	Photo date	Road name	Photo description (frame view)	Photo location (standing)	Facing
6	16	6/11/2018	East Pinery Ridge Road	View of a long segment of road that has several small gullies eroding into its road bed due to concentrated road runoff that has been trapped on the road surface for hundreds of feet. The gullies combine into a larger gully shortly before exiting the road prism and enlarging further as it carves into the outboard edge of fill.	Standing mid road below the confluence of the two gullies.	South-East
7	344	9/6/2018	Munch Canyon	View of the large diversion gully traveling down the inboard edge of the road and crossing the road. The upper extent of the large outboard fillslope gully is seen in the center frame.	Standing on the outboard edge of the road, above the large diversion gully that travels down the outboard fillslope.	South
8	344	9/6/2018	Munch Canyon	View of the large diversion gully downcutting through the road prism before exiting the road prism and eroding the outboard fillslope.	Standing on the outboard edge of the road, below the large gully that travels down the outboard fillslope.	North
