**Manzana Creek Watershed Anthropogenic Sediment
Reduction Assessment, Aquatic Protection and Road
Restoration Planning Project, Los Padres National Forest**

PWA Report No. 191029001
June 2019

National Fish and Wildlife Foundation (NFWF)
NFWF Grant ID: 0806.17.055580

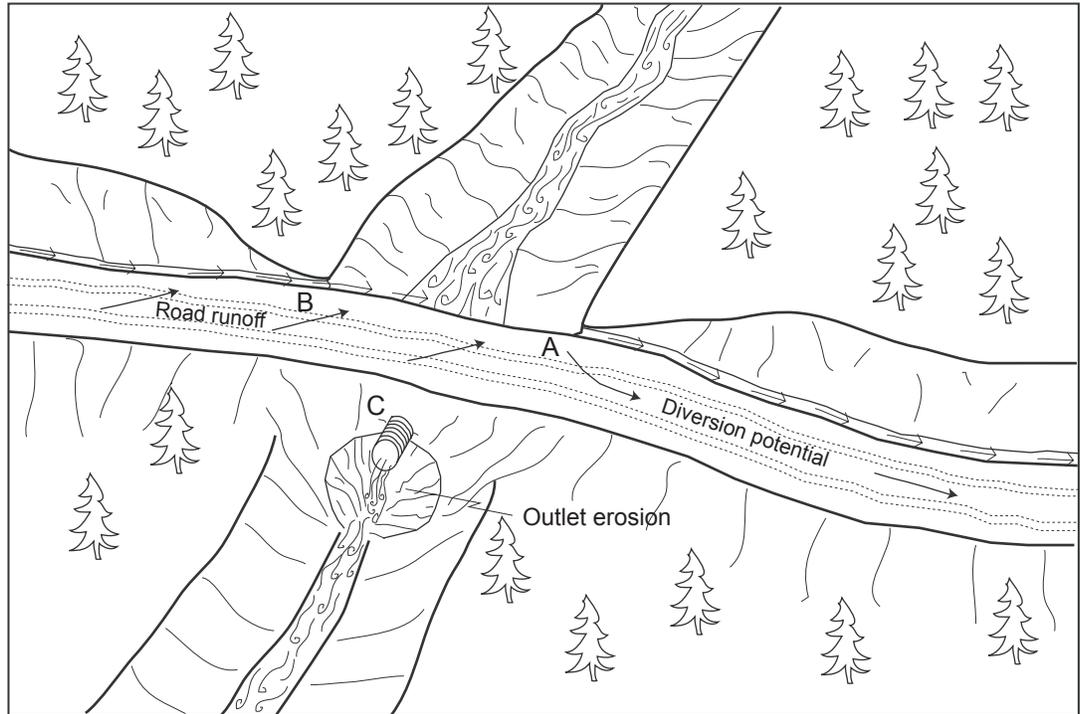
Problem condition (before)

- A - Diversion potential
- B - Road surface and ditch drain to stream
- C - Undersized culvert high in fill with outlet erosion

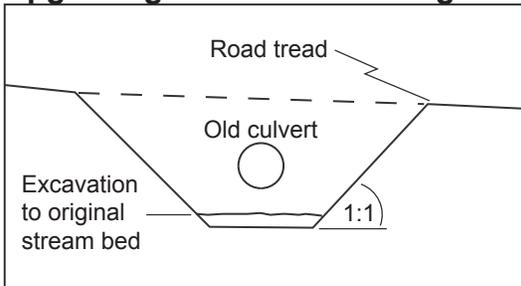
Excavation in preparation for upgrading culverted crossing

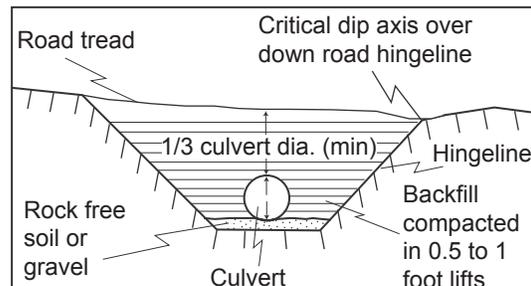
Upgraded stream crossing culvert installation

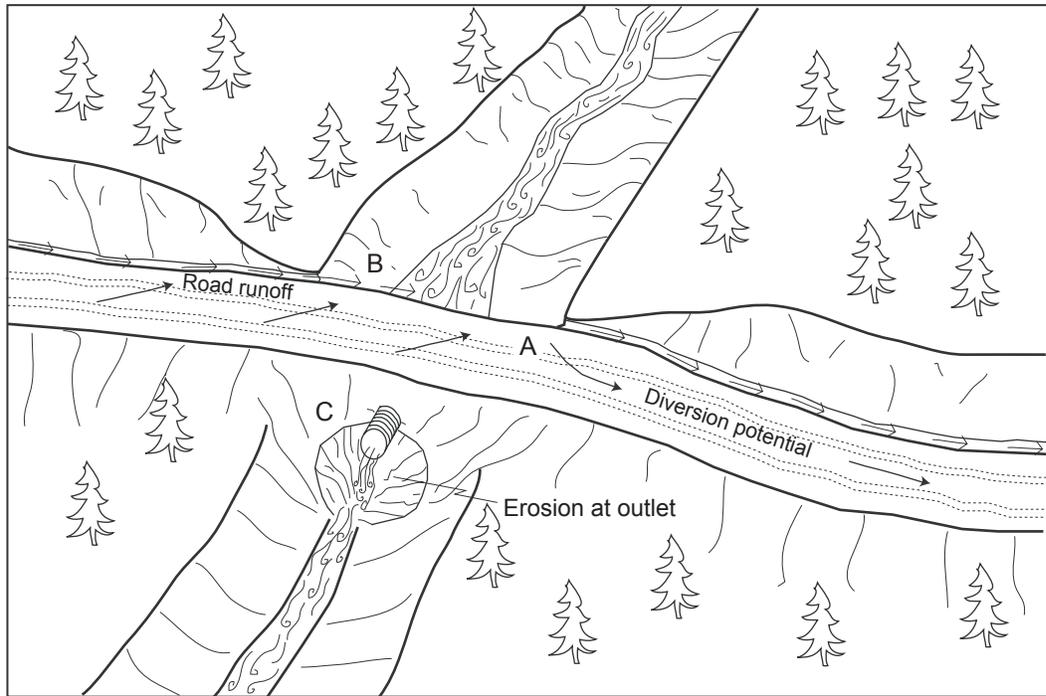
Problem condition (before)

- A - Diversion potential
- B - Road surface and ditch drain to stream
- C - Undersized culvert high in fill with outlet erosion
