San Luis Obispo County Low Flow Monitoring Report (2015-2018)

PREPARED FOR
Wildlife Conservation Board
1700 9th Street, 4th Floor
Sacramento, CA 95811

PREPARED BY
Creek Lands Conservation
229 Stanley Avenue
Arroyo Grande, CA 93420

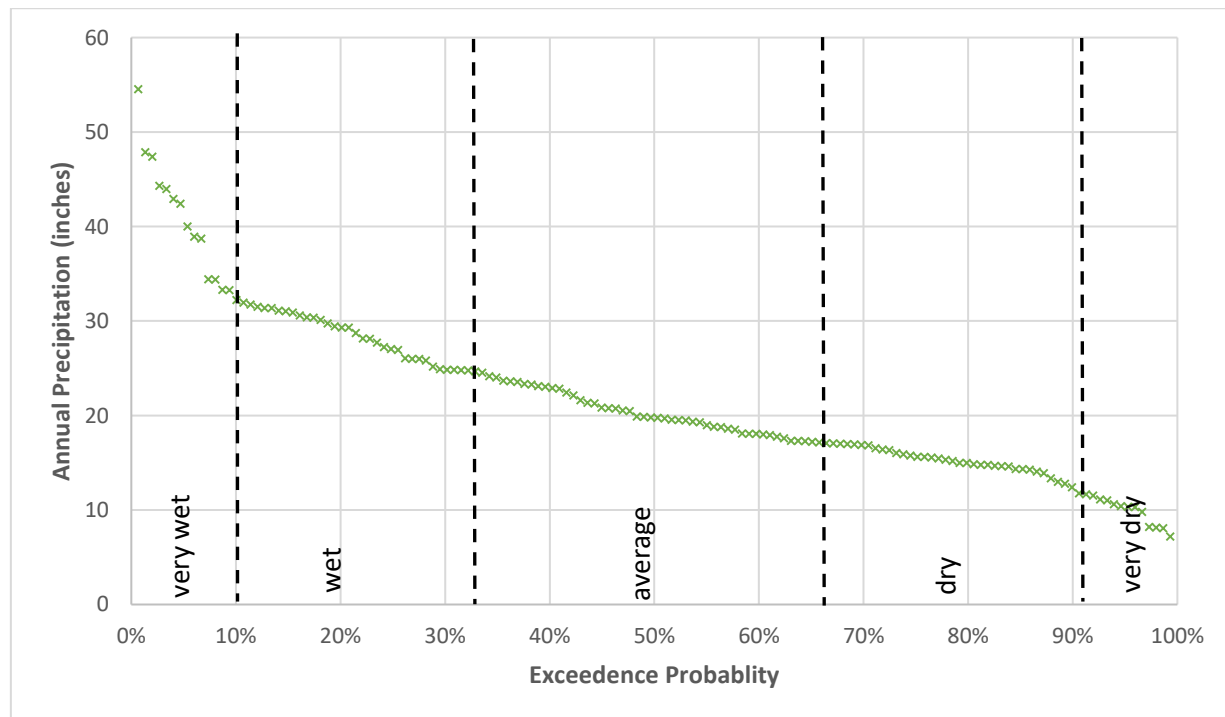
Figure 1. Precipitation frequency analysis conducted on Cal Poly total annual precipitation data (1871-2018)

To assist interpreting results, five water year types (very wet, wet, average, dry, very dry) were developed based on precipitation recorded at Cal Poly. The Cal Poly precipitation gage is located at an elevation of 330 feet and provides the longest period of record in the region (148 years). To determine the precipitation thresholds that define the water year types, a precipitation frequency analysis was conducted (Figure 1). The water year type definitions were created using commonly utilized exceedance probabilities, ensuring the average precipitation totals were bracketed and the extreme (very wet and very dry) categories have less than a 10% probability of occurring (Table 1). The probabilities reported in Table 1 are equivalent to the probability that in any given year the total annual precipitation will equal or exceed a certain total amount. For example, there is a 91% chance that in any given year the total annual rainfall will equal or exceed 11.7 inches and there is a 67% chance it will equal or exceed 17.0 inches. Utilizing the above water year type definitions and thresholds, Table 2 summarizes the total water year precipitation for water years 2015–2018. Precipitation water years start in July and end in June; whereas water years for surface flows start in October and end in September. For the purposes of this study both precipitation and surface water years are designated by the calendar year in which they end.

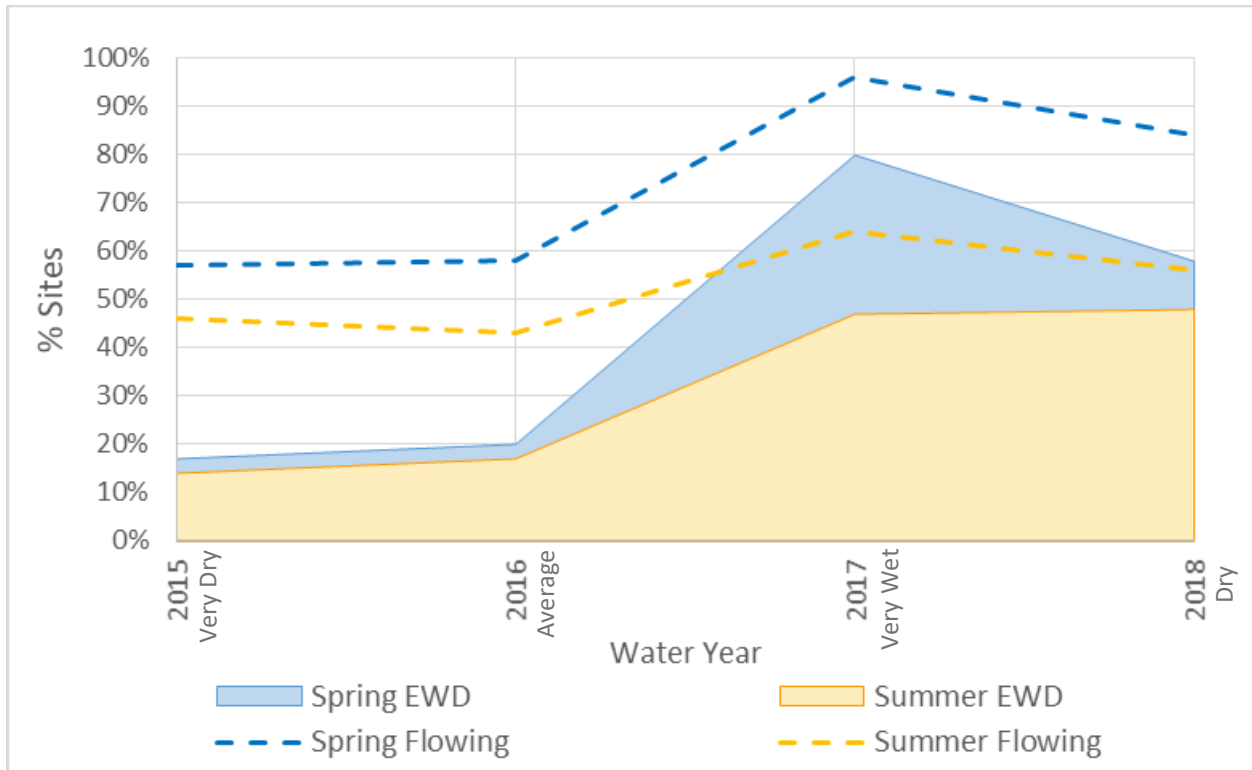
Figure 2. Percentage of study sites meeting environmental water demand (solid) and percentage of sites with flowing water (dashed line) in spring (blue) and summer (orange).

A summary of results are provided in table 4 at the end of this report and on-line by clicking on each site at: <https://creeklands.org/monitoring-ecologically-critical-creek-flows-in-san-luis-obispo-county/>. Not surprisingly the number of monitoring sites meeting environmental water demand (EWD) was lower in drier years than in wetter years (Figure 2, Table 3). However, there appeared to be a correlation in stream flow conditions and precipitation events from the prior year. For example, in 2016 which was locally an average year for precipitation, EWD was met in approximately 20% of sites in spring and 17% of sites in summer which was similar to conditions during the previous year (2015) where EWD was met at approximately 17% of sites in spring and 15% of sites in summer even though 2015 was classified as a very dry year based on low precipitation. The low percentage of locations meeting the EWD in 2016 is likely due to the extended drought that preceded 2016. Conversely, in 2018 which was a dry year, EWD was achieved at a much higher rate than in 2016 even though precipitation was lower in 2018 than in 2016. The high percentage of sites meeting EWD in 2018 (approximately 58% of sites in spring and 38% in summer) is likely due to the very wet conditions during the preceding year (2017), with the EWD met

at approximately 80% of the sites in spring and 47% of the sites in summer. These results exemplify that low flows are driven by subsurface groundwater conditions which in turn are impacted by multi-year, not single year, precipitation conditions. Flow monitoring results for all sites are included in Table 4 at the end of this report.

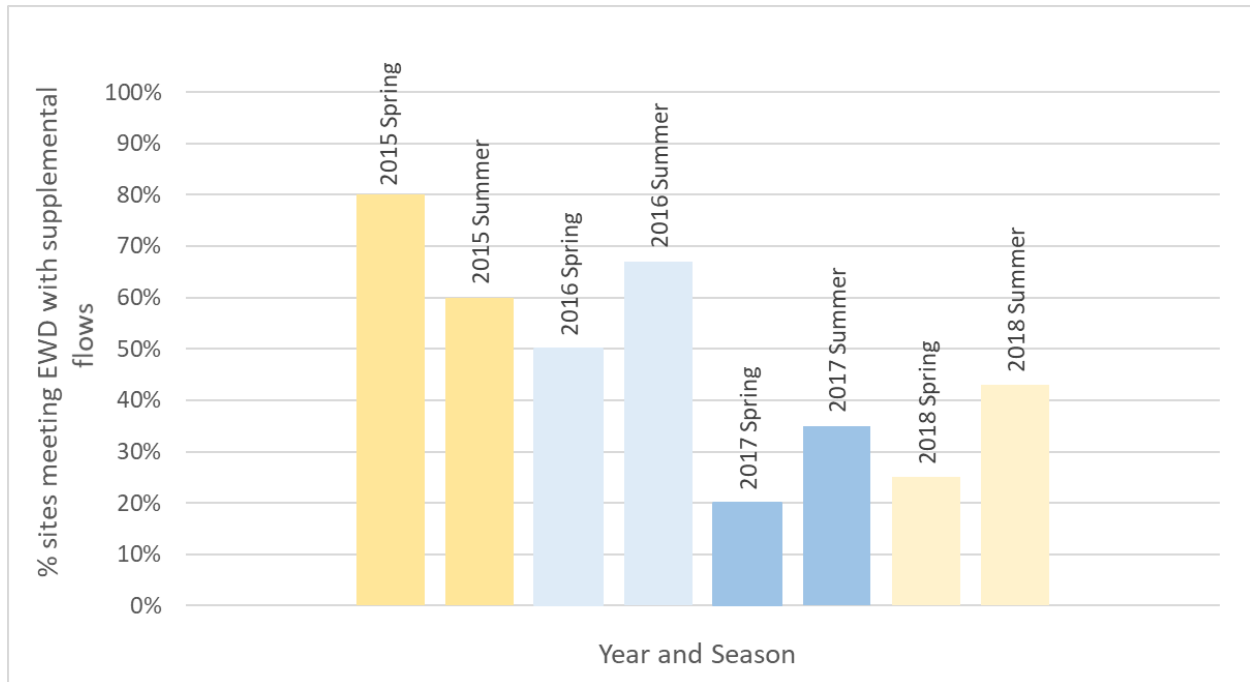
Figure 3. Percentage of study sites meeting environmental water demand (EWD) that are downstream of significant existing supplemental flow release locations (e.g. dam releases or wastewater treatment plant discharge)

Five creeks (Pismo, San Luis Obispo, Islay, Los Osos and Chorro creeks) typically maintained flow in their lower reaches allowing hydrologic connectivity to their estuaries and the ocean, either continuously or on an intermittent basis during the spring and/or summer. While this connectivity may be partially (or completely) due to human influence on Pismo and San Luis Obispo Creeks, other creeks like Islay Creek, which is located in Montana de Oro State Park, are less influenced by human activities.
